## **THE IMPORTANCE OF VEGETATION PROTECTION MAINTENANCE OF SLOPES IN EARTH DAMS FOR SURFACE EROSION PREVENTION**

**G. G. Dias<sup>\*</sup>, V. R. F. Oliveira, A. S. O. Furtado and I. T. S. Couto<sup>†</sup>**

<sup>\*</sup> Enemax Engenharia e Consultoria

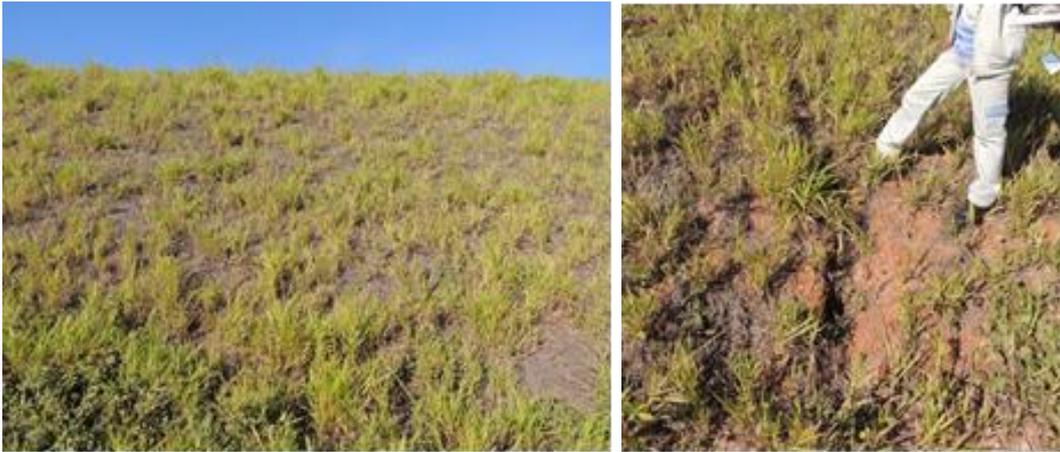
In 2013, the effects of choosing brachiaria as vegetation for downstream slope protection were observed during the inspection. At some points the slope had localized erosions and development of rills due to vegetation failure and lack of maintenance with systematic treatments of the sites.

Figures 2 and 3: Failure of protective vegetation on downstream slope (left). Erosive process identified during inspection in 2013 (right).

For the observed deteriorations it was recommended the recovery of the points with manual compaction of soil and planting of vegetation, in order to cease the evolution of the erosive processes. In places where there was a lack of protection, vegetation replanting was recommended in order to avoid the emergence of new erosive process.

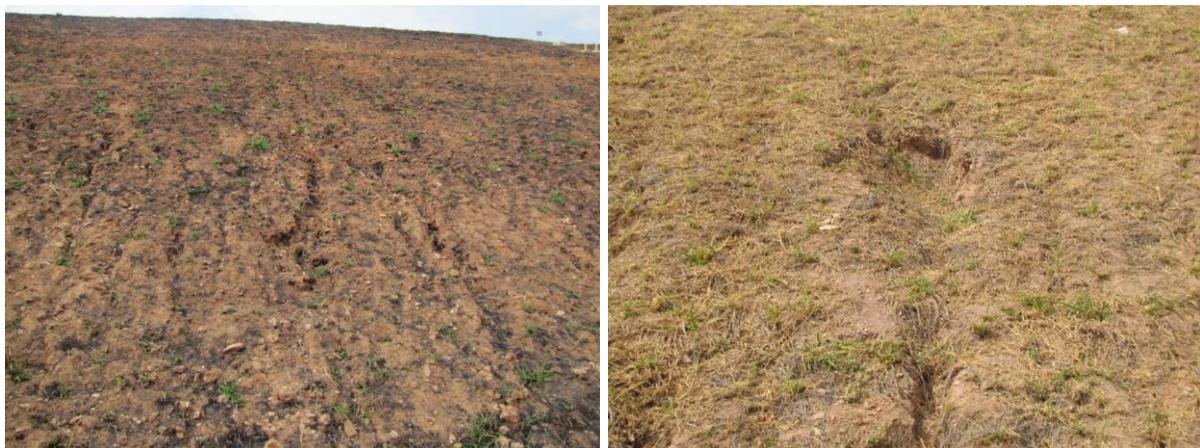
With low vegetation, it was possible to visually evaluate the evolution of surface erosions during the inspection, so that the observed erosions were comprised in sheet and rills erosions of greater expression. Despite an erosive evolution compared to the previous year, recovery recommendations remained the same in relation to 2013.

Figures 4 and 5: Sheet erosions observed along the slopes (left). Rill erosion observed along the downstream slope (right).

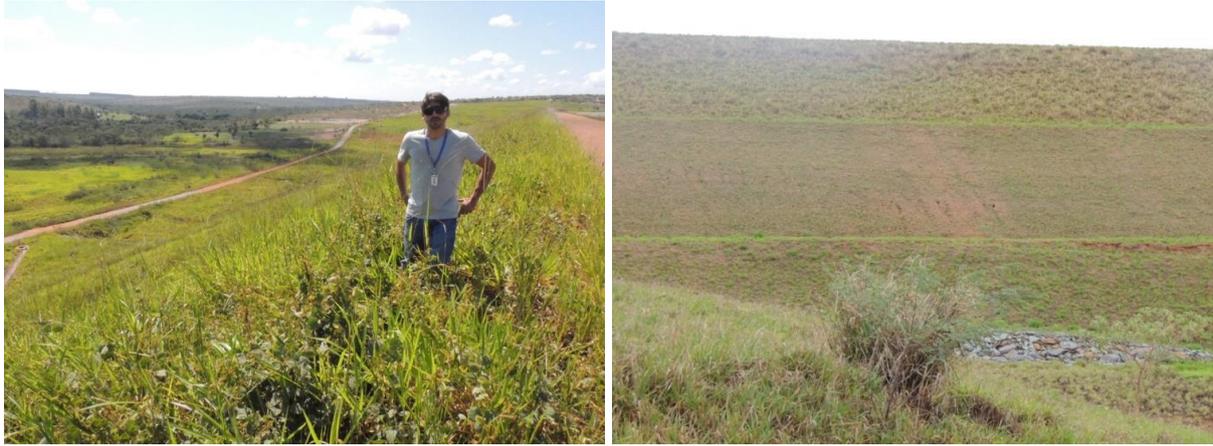
As early as 2015, the absence of systemic maintenance culminated in the vegetation growth along the slope, which made it difficult to identify deteriorations. Still, in some parts, points of rill erosion and slippage were visible. This situation made it necessary, as a more effective recommendation, the substitution of all vegetation protection by species of grass with regular surface growth.

Figures 6 and 7: High vegetation on downstream slopes (left). View of erosive process observed during the 2015 inspection (right).

In addition, the importance of the continuity of the preventive maintenance program was reinforced with the dam maintenance team, optimizing it so that the vegetation is kept low and homogeneous for the longest possible intervals, allowing the correct visual monitoring of the structure.

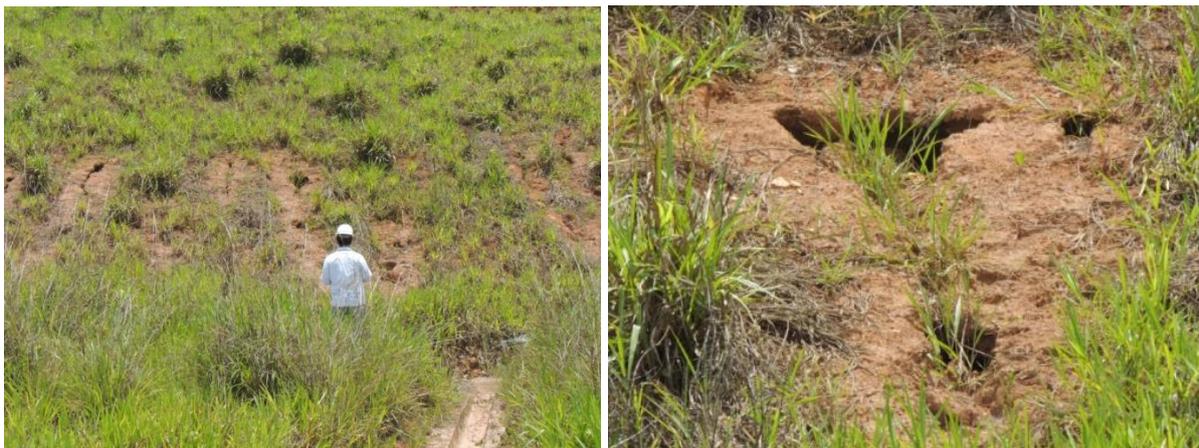
Attention to the maintenance of downstream slopes protection vegetation was reiterated in 2016. The protection was completely irregular, alternating stretches of very high vegetation with areas without any protection, which should have generated the evolution of the serious erosion picture previously observed.

Throughout the extent of the downstream slopes, erosions with considerable depths were perceptible along the entire structure. It is estimated that there were more than 300 points of sheet and rill erosions. Notably, the lack of maintenance of the slope surface and the use of brachiaria as surface protection were the agents of the problem.

Figures 8 and 9: View and detail of the erosive processes in advanced stages in the downstream slope.

The evidences of a visual assessing of the evolution of erosion processes had made it crucial to carry out corrective measures to recover the slopes. In addition to the previously recommended maintenance, erosion points needed to be recovered with soil filling and compacting within the erosions. Some more expressive areas might even require other recovery techniques.

The replacement of the protective vegetation with brachiaria was indispensable so that, after the erosion recovery, the deterioration would be definitively solved.

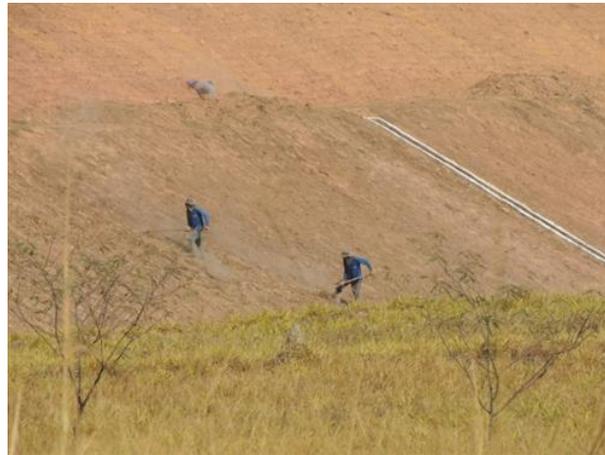
Figure 10: Recovery of the downstream slopes' erosions.

In 2017, the maintenance team's efforts to combat brachiaria and recovery of the downstream slopes from erosion are being decisive for the reversal of the deterioration and for the safety of the dam. The erosions observed in downstream slope in the last years were all recovered through the recomposition and compactation of soil in the erosions. The work was performed manually and it comprised the entire structure length.

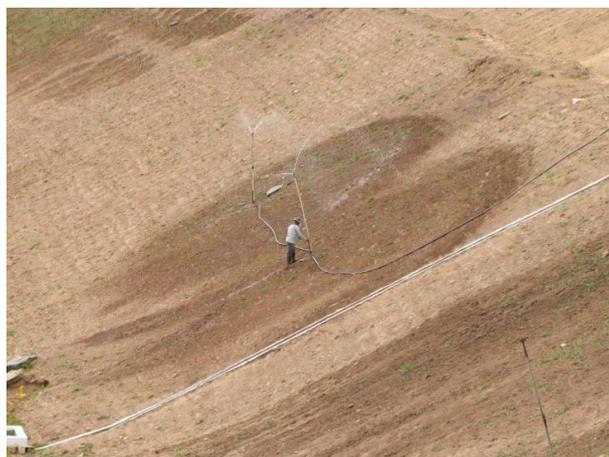
Figure 11: Region being irrigated after the sowing process.

The adequacy of the downstream slope protection vegetation consisted in the complete manual removal of the existing vegetation, with a predominance of brachiaria, and the planting of the creeping ground grass specie, which is currently in progress. The grass is being planted by sowing and irrigated by sprinklers in the dry season. Due to the resistance of the species and the easy proliferation of its seeds, the battle against the growth of brachiaria is carried out constantly by the maintenance team.
